ENTHUSIAST'S RESTORATION MANUAL SERIES

SECTION 2. 'UNWINDING' A GEARBOX

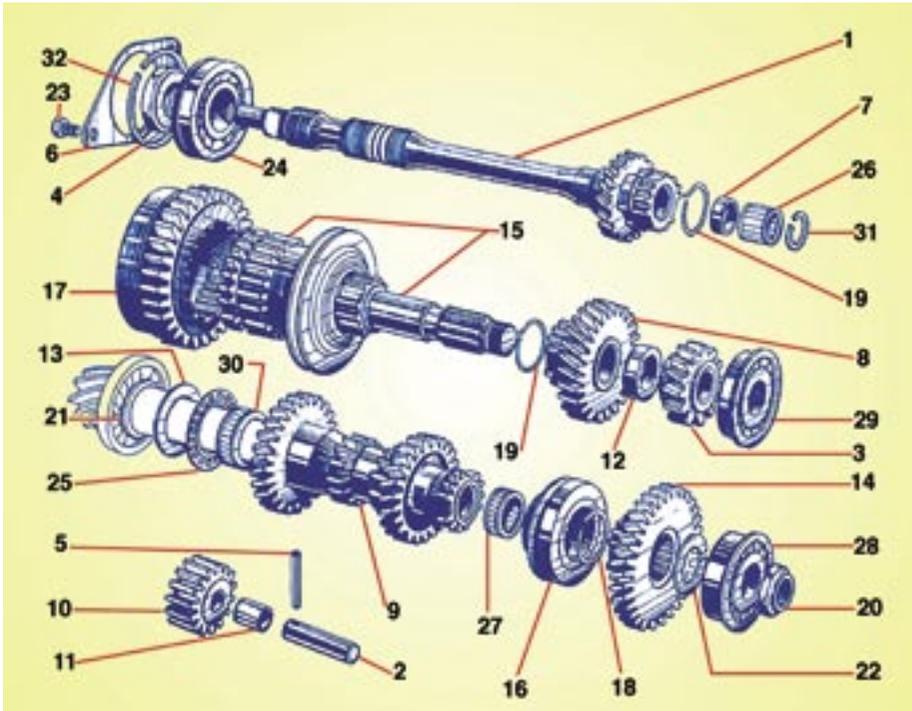
5-2-1. The gearbox components.

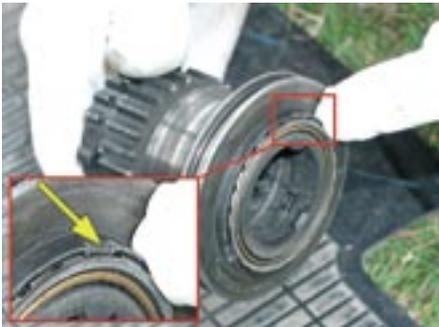
5-2-2. The ring for the second and third gear selector fork was staked onto the synchro hub when the gearbox was built (inset, arrowed). The problem is that the three stakings may not hold, especially on the later gearboxes.

The ring is threaded with a right-hand thread onto the synchro hub and, when it unscrews, the synchro hub will slide forward, into the third gear, which makes the gearbox engage third gear.

The symptoms of the problem are that you can engage reverse okay, if you put the lever in what was neutral, but if you can then find any other gear, the vehicle will be in both first and third, and will be immovable. Don't struggle with the gearstick - you'll only cause more problems.

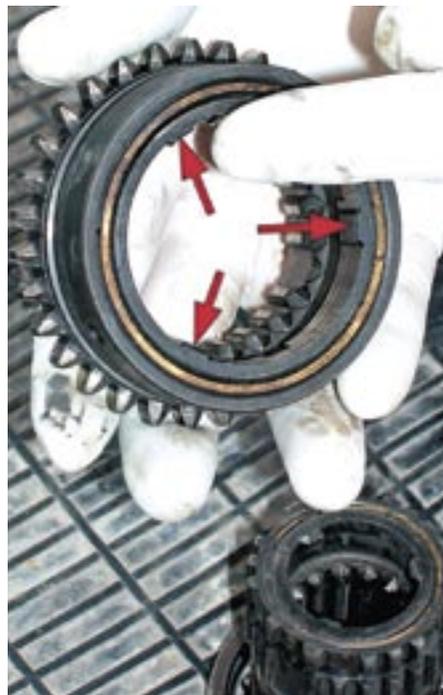
5-2-3. This ring is inside the synchro hub first gear, at the opposite end of the hub to the ring that unscrews itself.

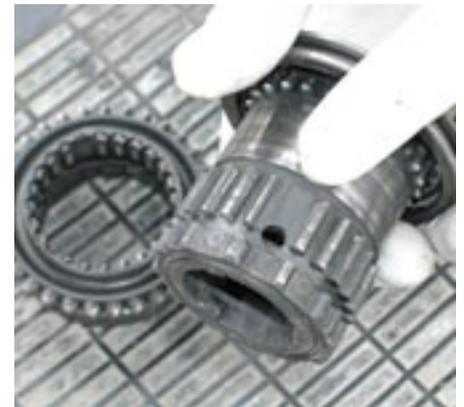
5-2-4. This internal ring has three dogs on it which slide in three slots on the second and third synchro hub. The dogs can come free of the slots, and the ring on which they are located can turn so that the dogs no longer line up with the slots. You then have the job of realigning the dogs with the slots before you can get the ring back on the synchro hub. (In other words, before you can push the first gear synchro hub onto the second and third gear synchro hub.)

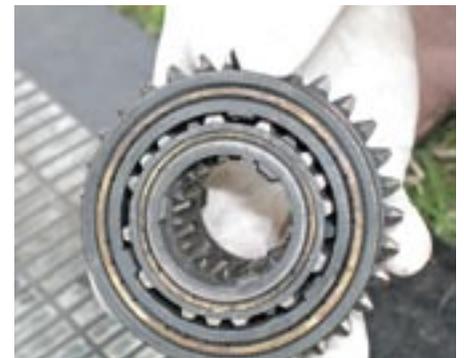
5-2-5. This picture shows one of the dogs located correctly in its slot.
